Manhole Inspection Summary

Manhole # S37GG_010MH

Insp Date: **3/21/07 12:19 PM**

Location Address: **1301 HOMEWOOD AVE**

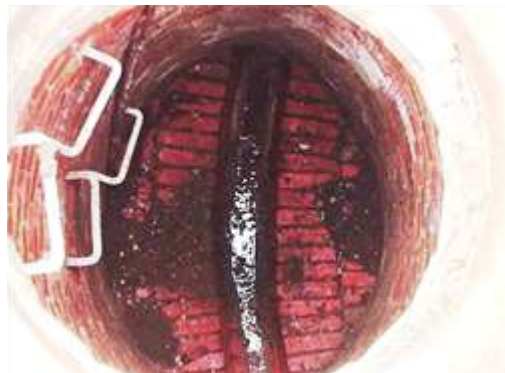
Top View

Evidence of surcharge - Bench debris.

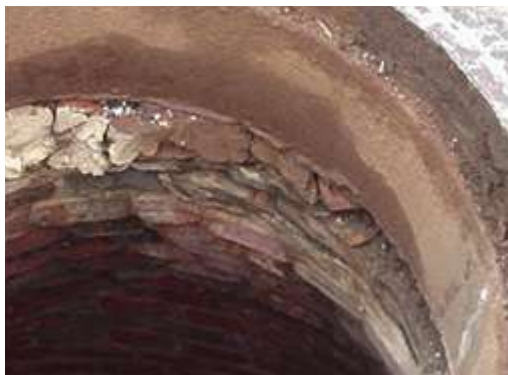
Defect

Frame offset. Frame leaks. Adjustment deterioration, loose brick and infiltration - other side.

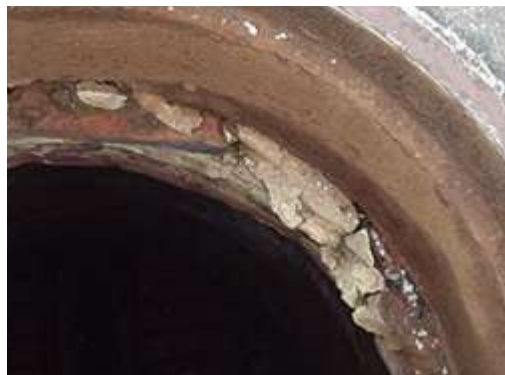
Defect

Frame offset. Frame leaks. Adjustment deterioration, loose brick and infiltration.

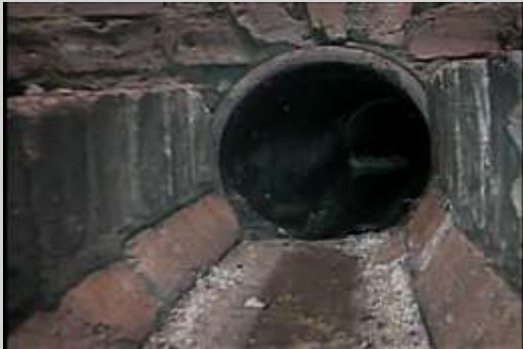
8 in. Circular Gravity Sewer Pipe Out @ 12 O'Clock

Barrel deterioration and infiltration. Channel deterioration.

Infiltration: **None** Pipe Seal Cond: **Roots**

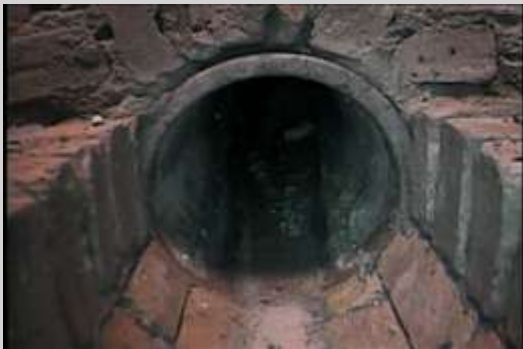
8 in. Circular Gravity Sewer Pipe In @ 5 O'Clock

Barrel deterioration and infiltration. Channel deterioration.

Deposits: ☐ None ☐ Mud ☐ Sludge ☐ Debris ☒ Grease

Infiltration: **None** Pipe Seal Cond: **Broken**
